Report on

Structural Inspection and Vibration Monitoring at
35 Shaggy Mountain Road
Herriman, UT

July 25, 2012

EARTH DYNAMICS
2284 N.W. Thurman St.
Portland, OR 97210
(503) 227-7659
Project No. 12110

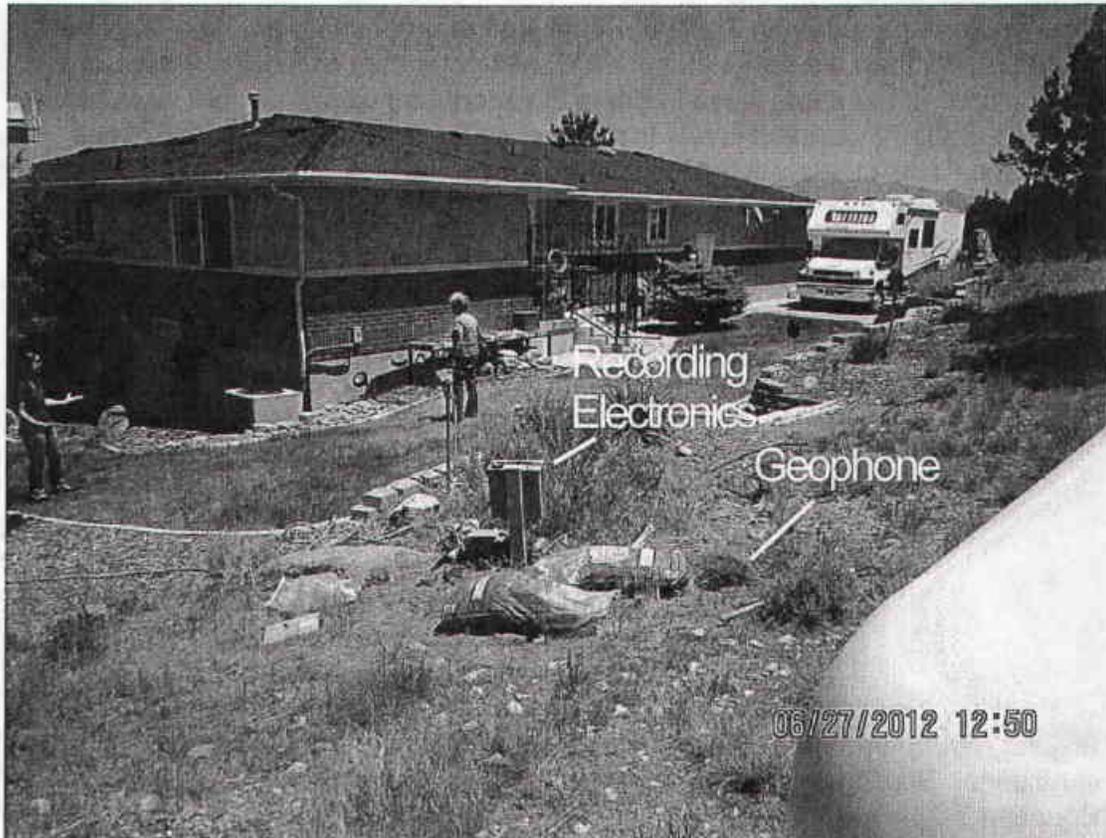
An InstanTel MiniMate Plus seismograph was installed on June 27, 2012 near the propane tank at the southwestern corner of the Crane home. A photograph of the installation location is shown in Figure 5-1. The InstanTel seismograph is a stand-alone 3-channel seismograph that is capable of recording ground motion in three orthogonal directions. The vibration transducer for the seismograph was installed with three spikes in firm soil approximately eight inches below the ground surface.

The seismograph was programmed in "histogram-combo" mode. In this mode, the seismograph monitors and records the peak vibration level in any direction over a preset time interval of one minute. In addition, if the vibration levels exceed a preset trigger threshold, full waveform data are recorded. Full waveform data are used to compute spectral frequency values using the Fast Fourier Transform (FFT). Trigger threshold values are typically set slightly higher than the ambient background vibration level so that waveform data would be recorded only for unusual activity. For this project, the trigger level was programmed to 0.04 inches per second (ips). The seismograph was connected via cellular modem to a computer at the Earth Dynamics office in Portland, Oregon. Data from the seismograph were downloaded each night to this computer. Data were continuously recorded from 13:46 on June 27, 2012 through midnight on July 14, 2012.

Figure 5-1. Overview of seismograph installation.
